COASTAL EROSION DYNAMICS AND LANDMASS CHANGE ALONG
CAPE COAST - SEKONDI COASTLINE IN GHANA

THESIS SUBMITTED TO THE DEPARTMENT OF GEOGRAPHY AND
REGIONAL PLANNING OF THE COLLEGE OF HUMANITIES AND
LEGAL STUDIES OF THE FACULTY OF SOCIAL SCIENCES,
UNIVERSITY OF CAPE COAST, IN PARTIAL FULFILMENT OF THE
REQUIREMENTS FOR THE AWARD OF DOCTOR OF PHILOSOPHY
DEGREE IN GEOGRAPHY

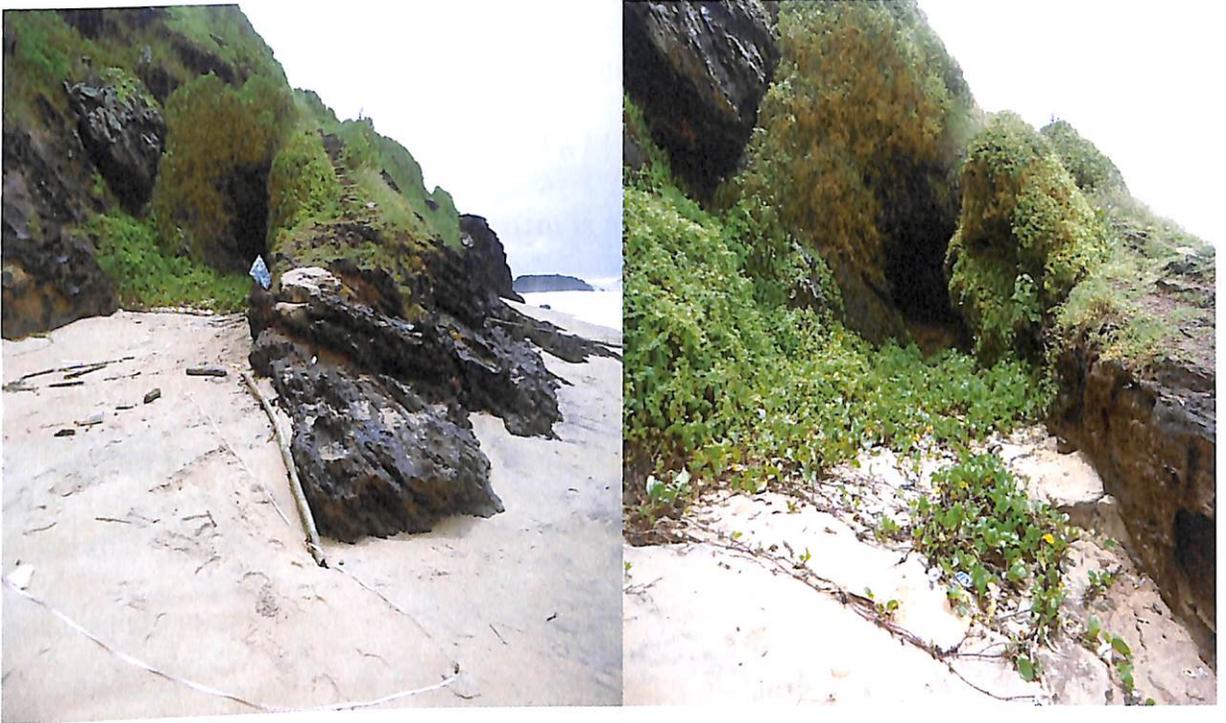
Plate 1: The main cave at Gold Hill Beach in Komenda. Source: Field survey, (2013).

From the field survey, the distance from HWM to the entrance of the main cave in the rainy season is 13.3m while that of the dry season is 21.3m. The cave is also protected by a headland-like jetty on its immediate south western part.

Average distance from the LWM to the cave is 38.8m. Out of this, the sea could erode up to 25.5m after which deposition begins. Thus the change between eroded and deposited areas is 13.3m. This means that at the time the cave was being formed, the sea could erode for extra distance of 13.3m but now it does not. In the dry season, it has to erode for an extra 17.5m. It could thus be inferred that the sea has generally retreated though the waves continue to grow stronger and stronger. On the other hand, the total collapse of the cliff face around the Gold Hill beach has also caused the land to retreat further. This notwithstanding, some other parts of the cliff which are closer to the sea still suffer from wave attack but

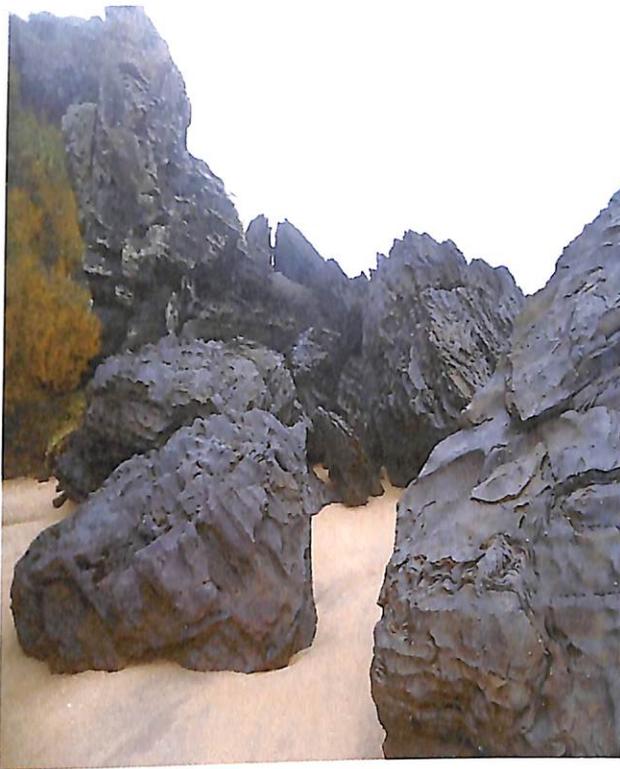
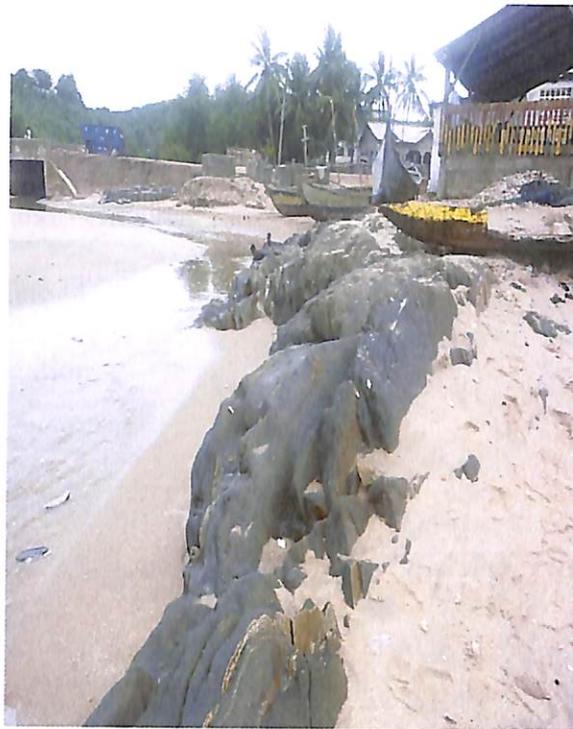
Plate 2: Exposed rocks along the coast of Komenda (A) and Cape Coast/Ekon (B). (Field photograph, 2014).

From Plate 2 A and B, it can be seen that the dynamics of coastal erosion, including sub-aerial processes have acted on the rocks for a long period of time thus exposing them. It was also revealed by the local inhabitants that these rocks come under serious wave attack during high tides.

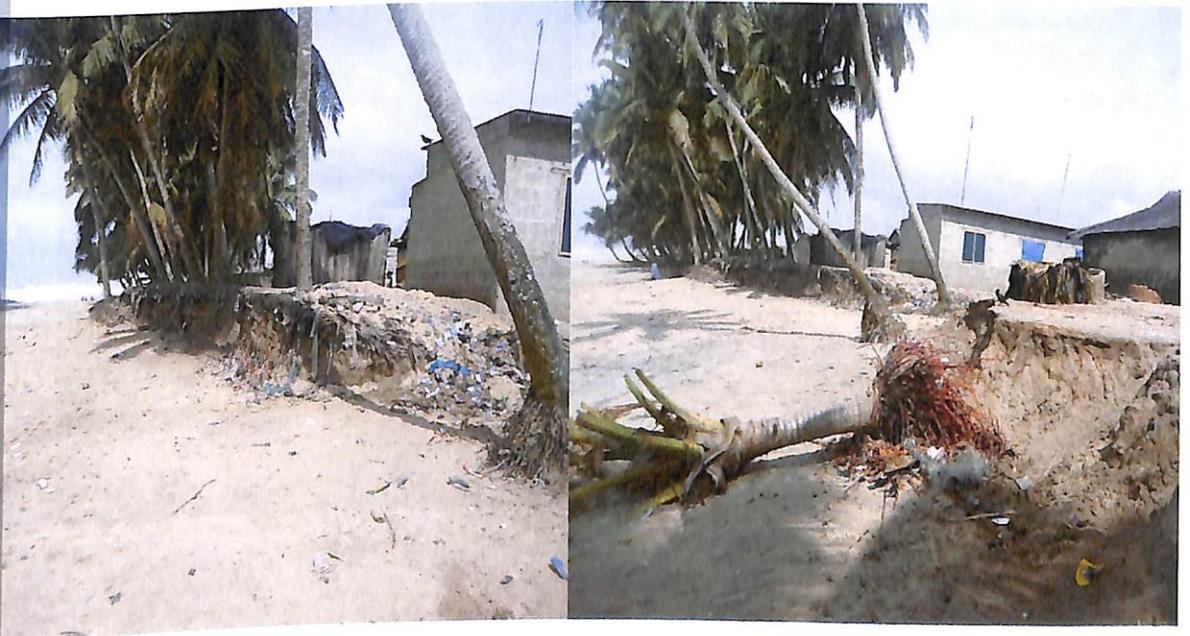
Plate 3: Sea erosion threatens residents of Komenda as it attacks both dwelling houses and destroys vegetation. Field photograph, (2014)

From Plate 3, it is seen that the effect of sea erosion was very intense from 1972 up to about 2005 but has been retreating in recent times. Human habitation had been threatened and coconut trees uprooted. In the field survey, it was found that the sea had been accreting in recent times and hence has retreated leading to raised beaches as revealed in Plate 3. In Plate 4 A, a dwelling house was abandoned in Komenda due to erosion and inundation.

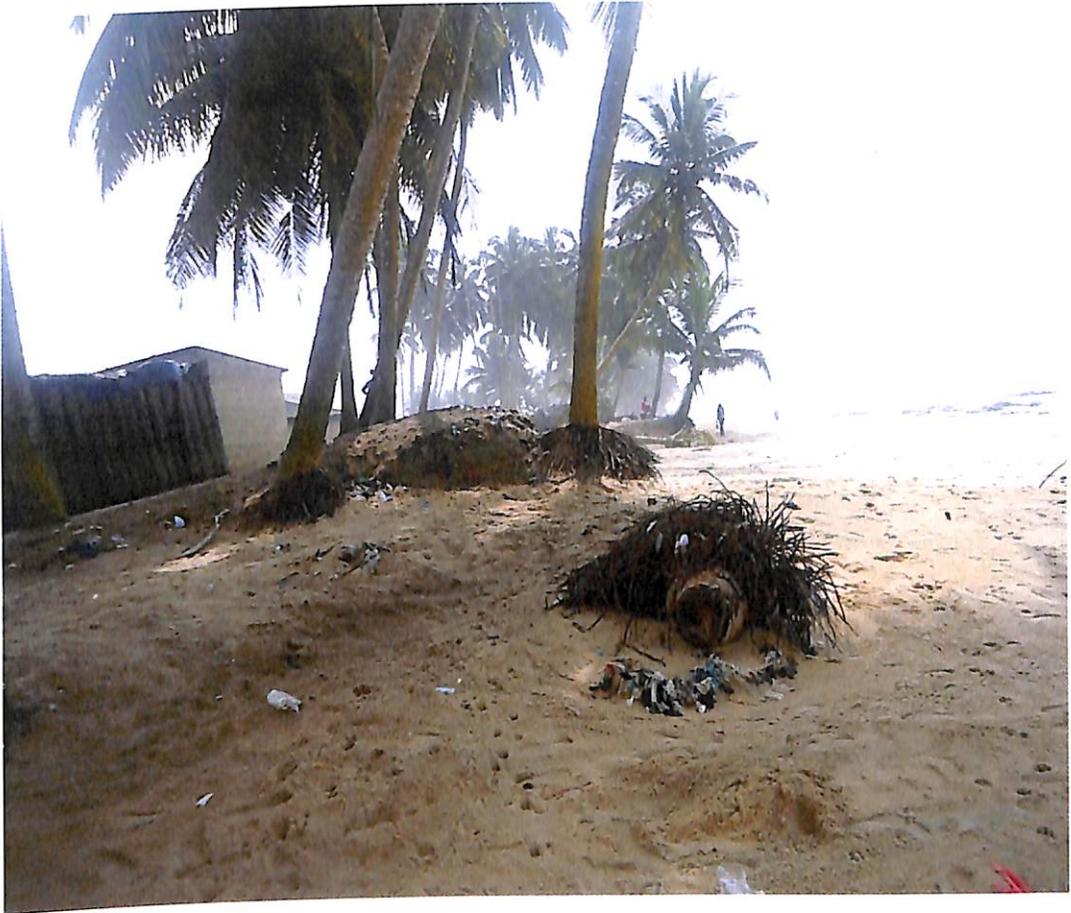
Plate 4: A dwelling house is abandoned at Komenda due to sea eroaion.
(Field survey, (2014).

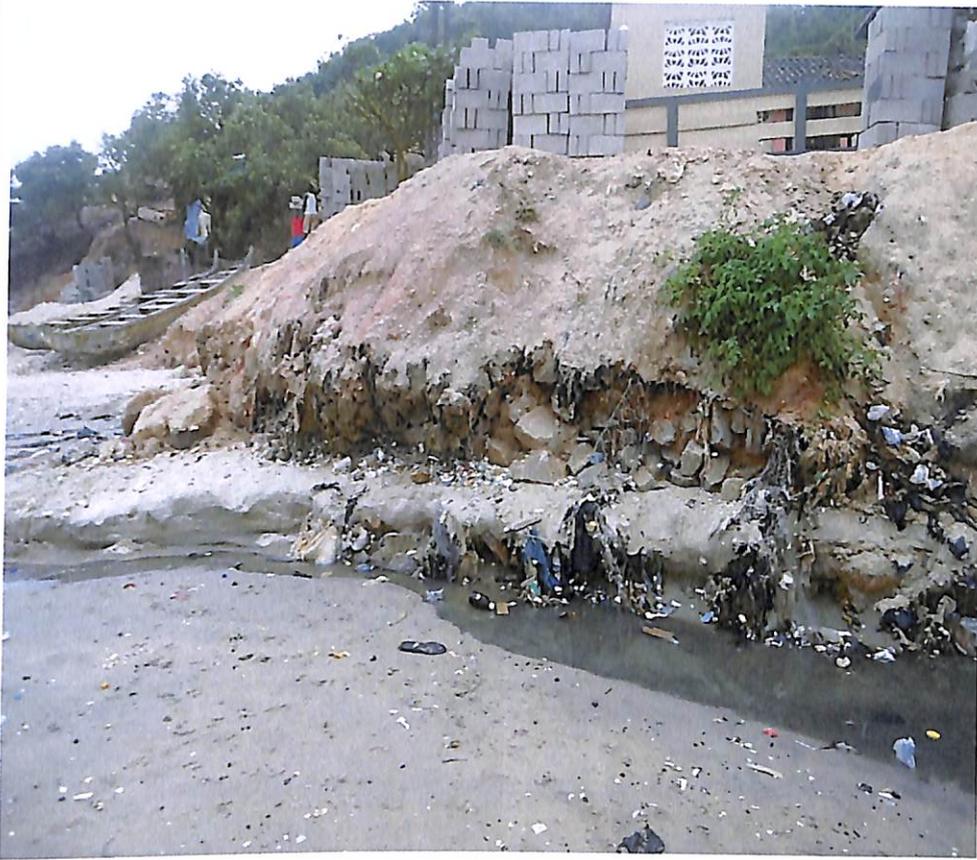
Plate 5: Seriousness of sea erosion at part of Cape Coast beach. Field photograph, (2014).

In Plate 5, coastal erosion is so intense that the residents have used boulders, sand bags and nets to check the advancing sea in Cape Coast. Ironically, some of the residents at the same time mine sand from the beach laying blocks. Some of the blocks are parked as shown in Plate 4 B. Asked why they have been mining sand at the beach, one of the residents/respondents retorted

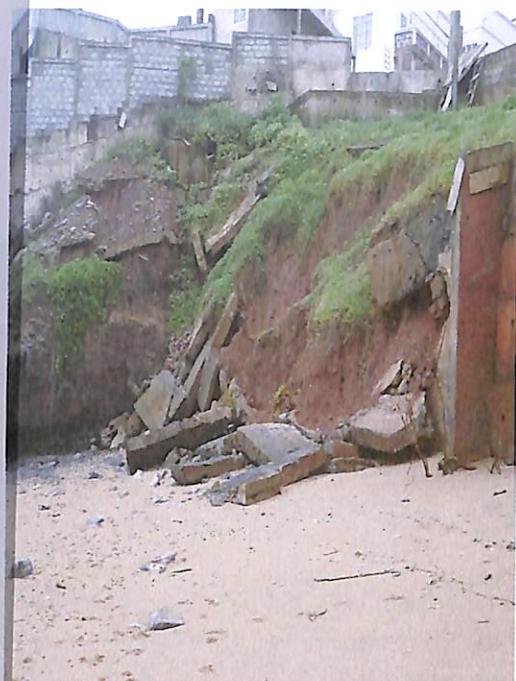
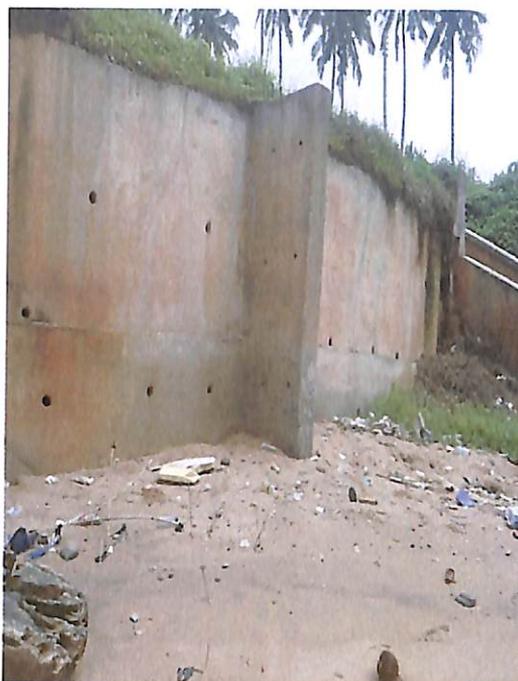
Plate 7: Local initiative aimed at dealing with sea erosion at Turtle Cove (Sekondi). (Field survey, (2013-14).

1. Fishermen avoid going to sea when they anticipate that the sea will be 'rough'. This is a coping strategy and not a concrete effort at managing sea erosion.
2. Ban on commercial sand mining.
3. Sea defenses through the use of granite, concrete, sand bags, bamboo fence and vegetation.
4. From Plate 7, 'A' is under attack from both waves and sub-aerial processes such as erosion, weathering and mass wasting. These have contributed to the collapse of that part of the concrete fence. 'B' is still intact with vegetation growing at the upper portions. In 2013, the entire structure was intact but a later visit to the place in May 2014 revealed that parts of it have collapsed.

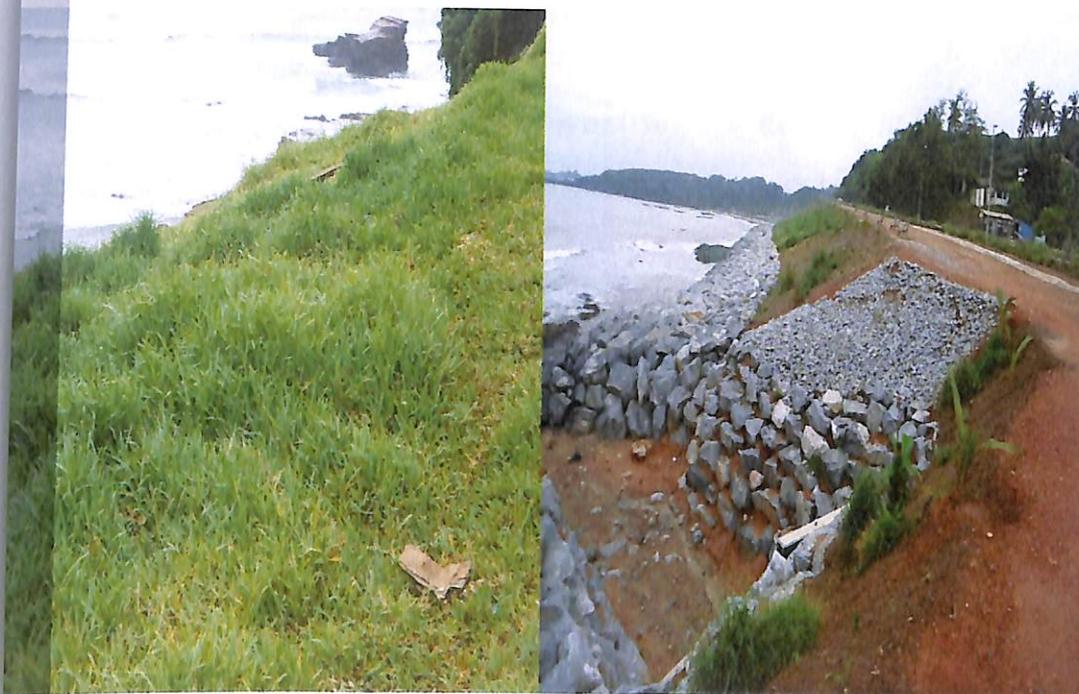
Plate 8: The use of granites as sea defense backed by vegetation at Ngyiresia near Sekondi. Field survey, (2014).

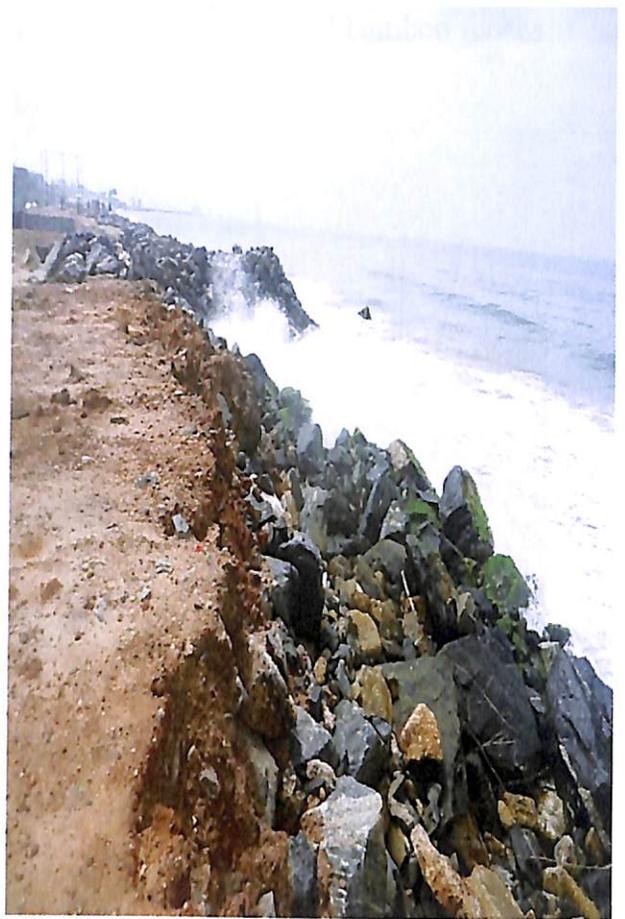
Plate 9: The use of granites as groynes for sea defense along the coast of Sekondi

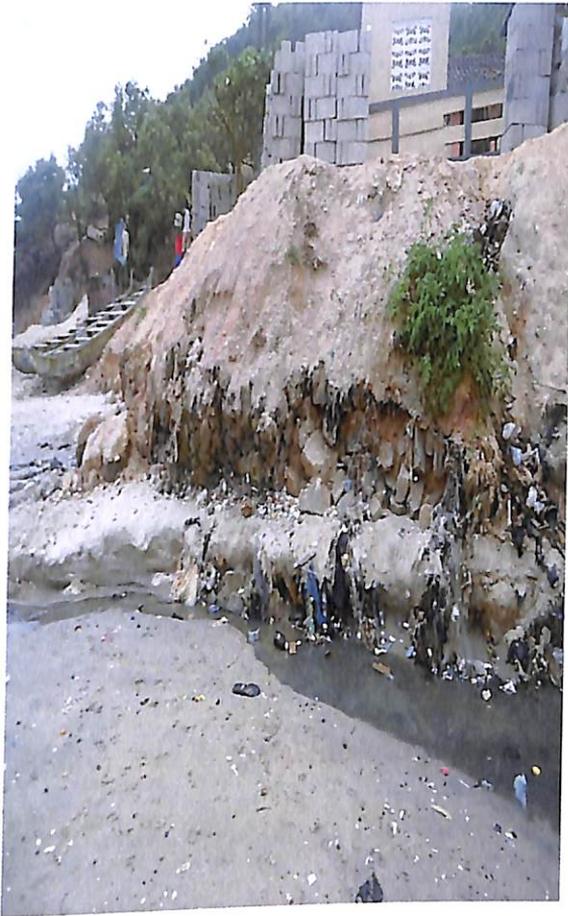
their own initiative, they use sand bags, fishing nets, boulders and bamboo fences to control sea erosion as shown in Plate 10.
