Water Safety Planning and Implementation in a Ghanaian Small-scale Water Supply System

This study was conducted on the Assin Fosu Small Town Water Supply System (AFSTWSS) in the Central Region of Ghana primarily to assess the practice of water safety planning in the system and how it affects

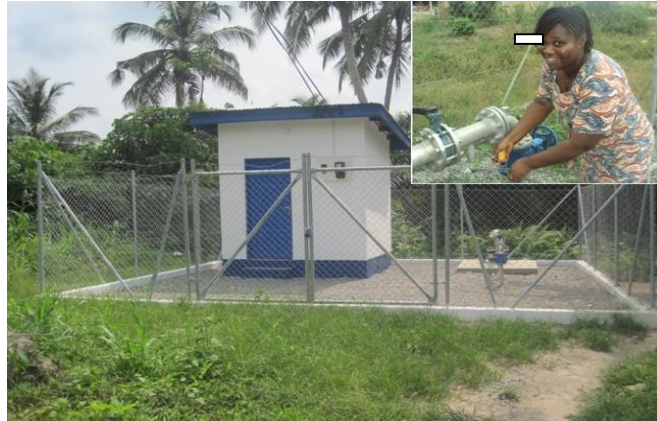
Plate 1. Water source – borehole and pumping station – at Assin Fosu
(Credit: Authors)

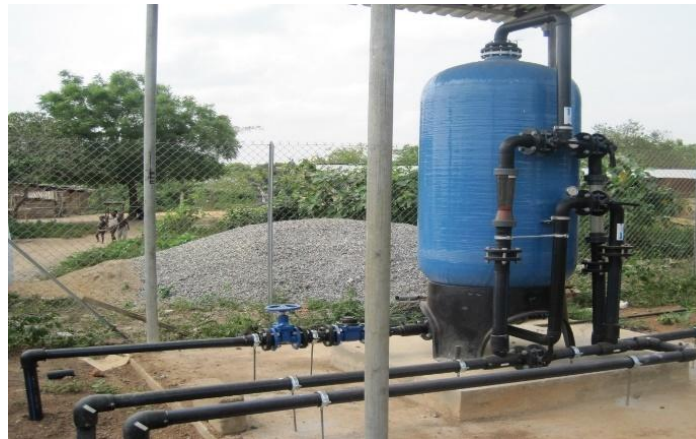
Plate 2. An Aquatec filtration unit installed in the AFSTWSS
(Source: ANMA [20])

It was expected that the high colour and turbidity of the raw water would be reduced to the recommended levels after undergoing treatment in the filtration units but the reduction observed was marginal and inconsistent as seen in Table 4. This could be attributed to inefficient filtration which could primarily result from poor management of the filtration units. The management of the filtration units was one of the areas where the stipulated operational (regeneration) schedule was not strictly followed.

well managed to improve upon the levels of turbidity since its impact on the water quality goes beyond aesthetics to affect disinfection efficiency. It is also important for the dead ends in the distribution systems to be flushed regularly in order to minimise the conditions which favour bacterial growth.

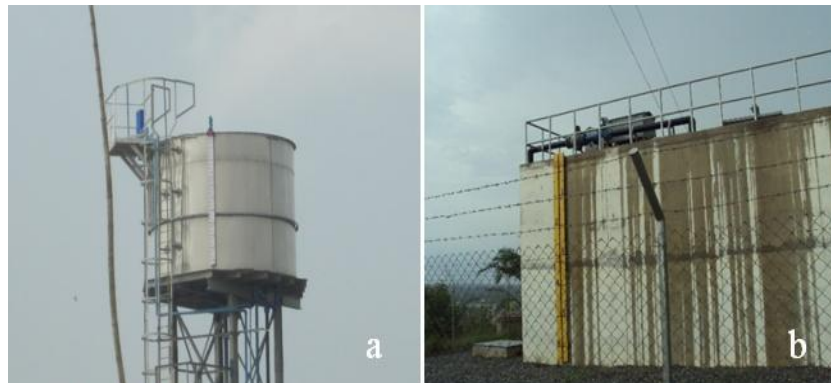
Plate 3. Service reservoirs of the AFSTWSS (a) Elevated aluminium reservoir; (b) Ground-level concrete reservoir
(Source: ANMA [20])
